## POND SURVEY 2026

### ILKETSHALL ST ANDREW COMMONS

**POND SURVEY & MANAGEMENT RECOMMENDATIONS MAY 2026:  
ILKETSHALL ST ANDREW COMMONS**

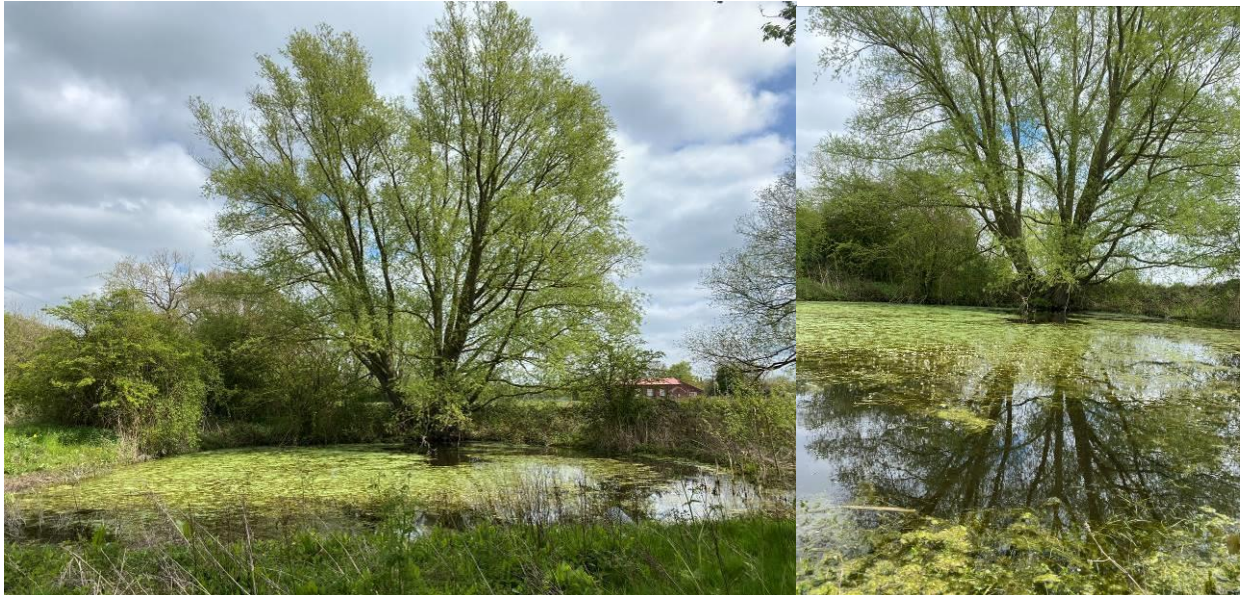
**3<sup>rd</sup> May 2023:** As advised in 2020, the Azolla water fern that was covering the pond entirely in June 2020, has completely disappeared. The shallow water over a firm pond substrate looks clear and is full of plants taking over the depth of the water column (mostly water starwort), leaving very little open water anywhere. Water crowfoot covers 15% or so of the water's surface. 12 aquatic/emergent species were recorded which is a good range of plants. Great crested newt were recorded breeding on water mint leaves but because the pond is so densely vegetated and most of it with narrow-leaved plants, it is not currently optimum for breeding for the newt which likes broad-leaved plants on which to lay eggs and plenty of open water for courtship. *No invertebrate sample taken as too dense to sample easily.*

Water levels clearly fluctuate significantly from mid-winter (when an overflow pipe is needed to stop the track draining) to the summer when water levels go down considerably in this shallow pond. It is not a garden pond and as such it will develop and without cattle to graze the margins and 're-set' the vegetation annually it will go through various very natural changes in vegetation in response to water and nutrient levels and shade. Without intervention (cattle or machine), it will eventually become dominated by reedmace or, as before, branched bur-reed and, may require some patch-scraping on a little and often basis to remove accessible areas of the pond on rotation or a more brutal and expensive whole-pond intervention.

## Recommendations

- As 2020: Rotationally/regularly strim or flail 2-3m pond margins to keep scrub from getting well established again and to enable all year access to monitor pond and visibility of the pond in addition to creating some structural diversity amongst the scrub-grass-nettle mosaic.

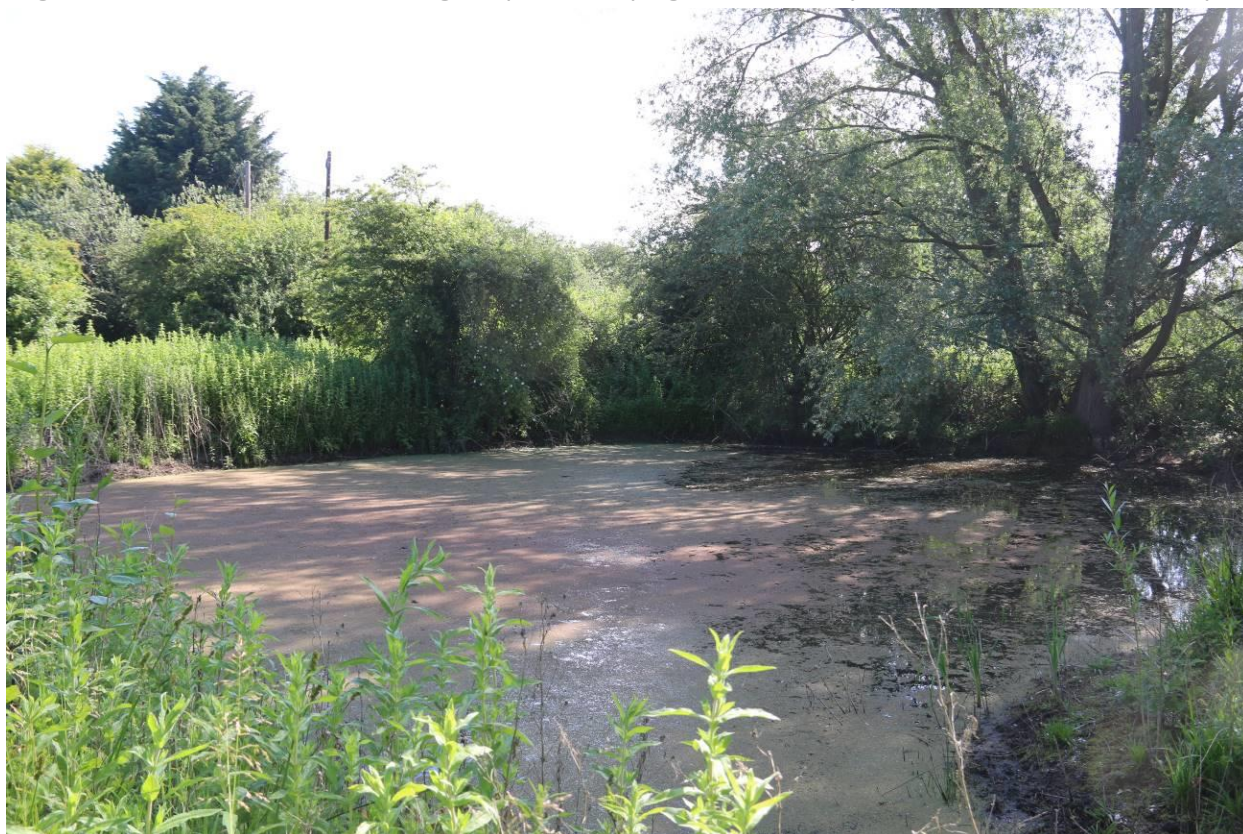
Like Great Common Pond 2 in 2017, this pond is now completely covered in *Azolla filliculoides*, the non-native Water Fern. *Azolla* multiplies very quickly and effectively shades out submerged vegetation and I could see none easily. 2020 records below summarise what was visible in the emergent zone and includes Branched Bur-reed which has returned and Reedmace which is just getting established – and poplars and sallows are occasionally seeding along the banks. In the absence of browsing livestock accessing the pond edges, all of these will need some regular patch-scraping to ensure they don't take over this shallow pond.

To avoid contaminating any subsequent pond I was surveying (and because it is almost impossible to do it through the layer of the floating leaved fern), I did not pond dip to sample the aquatic invertebrates but it is fair to assume that those species recorded in 2017 will still be present except for the Whirligig Beetle which will not like the lack of open water to whirl about in but will soon return when the *Azolla* disappears.

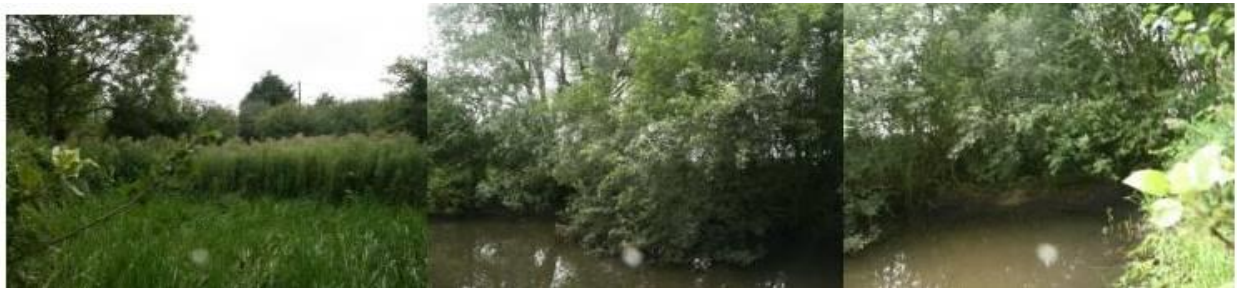
**Pond 1 - 30<sup>th</sup> July 2015:** I beat a route through nettles to the pond edge to look at this pond and then was able to walk along the water's edge a little way and so have a good look. The pond was extremely shallow (4" of water), fairly brown but clear (reflecting the leaf litter build up) and a dip yielded very few invertebrates (water boatman, hoglouse, pea mussel) and a leaf litter layer of 6"+ at the margin so probably a little deeper in the middle of what appears to be a very shallow pond. Interestingly there were no stickleback apparent (have they died after a droughty year?) but a proper net would have to be done to really establish this. And Crassula was not evident either (did anyone every spray this?) although a better look at the whole pond may reveal it. Hairy willowherb, bittersweet, water mint, creeping bent, water forget-me-not, watercress and gypsywort were all present along the margins but there were no submerged aquatic plants so I suspect that any Great Crested Newts will be breeding in other nearby ponds or occasionally egg laying on leaf litter.

Bur-reed dominates the northern 50% of the pond and the southern margins are shaded by a large willow and salallows. Beyond is some valuable scrub, nettle, thistle and grass. A turtle dove was purring in the thick blackthorn scrub which was excellent. The poplars appear to have been coppiced but are now re-growing with a nettle understorey.

### Recommendations

- As neither fish nor Crassula appear to be present, or present in large number/amount, it would be worthwhile restoring this pond if you already have machinery on site or nearby.
- At present it is difficult to see into the pond at all. The pond could be made more attractive and visible to both the cottage owners and anyone walking by simply, regularly, mowing the fringe of nettle, bindweed and hops on the narrow margin/edge next to the trackside. The trackside 2-3m margin could be topped occasionally too in a wavy scalloped shape that makes it 'look' managed and provides a little diversity in sward ie grass and nettles/bindweed/hops.
- Regularly re-coppice suckering stools of poplar to minimise the shading near the pond.
- Retain the thorn tree on the eastern edge.
- Coppice the large willow to reduce shade to the south and to reduce leaf litter.

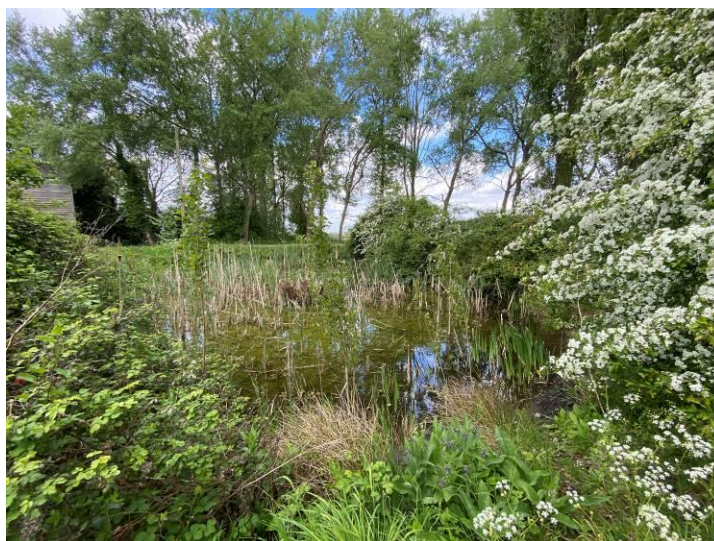
**7<sup>th</sup> May 2026:** The pond is very little changed from 2023 the water lilies appear to have some clear water beneath them and have spread to cover 25% of the pond. It was too dense with New Zealand Pigmyweed to sample and no broadleaved plants were accessible to search for great crested newt eggs but they are probably still breeding here in low numbers.

**2026 recommendations (LMC propose work in 2026/27)**

- I am very wary of recommending any machinery work at all. IF you are keen to open it up, any contractor needs to ensure that he is aware of the NRP problem and not contaminate any other pond. So ANY work here needs to be the last pond that is worked on in the Commons and the machinery should be totally washed down to remove all fragments prior to moving off site (tiny fragments 5mm long can survive and be taken to another pond or ditch somewhere in Suffolk!). Until there is something to control NRP, I would recommend you leave large scale machinery restoration for another time.

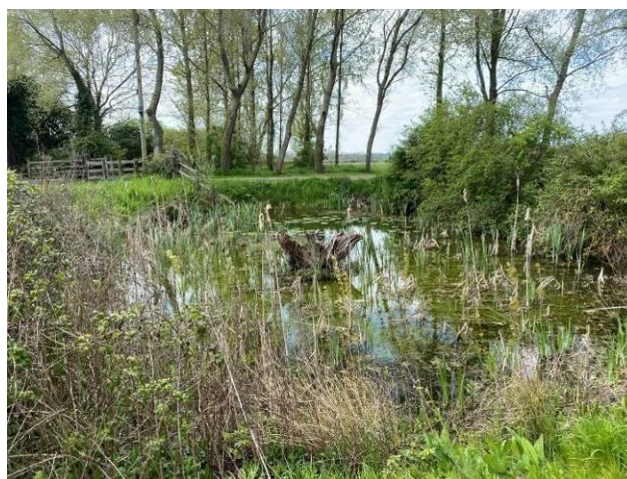
**3<sup>rd</sup> May 2023:** This is a really pretty pond, full with clean water but, sadly, New Zealand Pigmyweed (NRP) has completely taken over this pond (95%) – surface and water column - and is out-competing even very competitive species such as reedmace but a few others are hanging on. Great crested newt eggs were evident on one or two willowherb leaves. Several birds such as dunnock, robin and wren were using the scrub which is valuable adjacent to the pond.

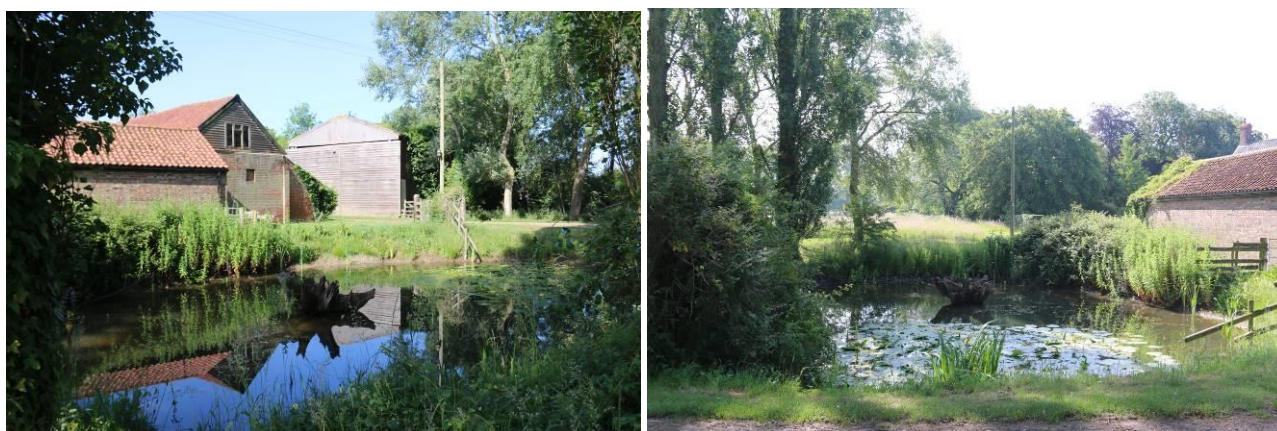
**15<sup>th</sup> June 2020:** This shallow pond has not been surveyed since 2008 but in 2020 supports much the same species recorded then except the very invasive non-native *Crassula helmsii* (New Zealand pigmyweed) is much less dominant and the introduced Yellow Water Lily has taken over 35% of the pond at the Dairy Farm Barn end. *Crassula* is damaging to a pond environment (can take over completely and deoxygenate the water) and may well have been accidentally introduced when the Yellow Water Lily was as it is often brought in with garden centre plants. I don't know why the *Crassula* should lessen its dominance unless it has been cleaned out relatively recently or, more likely, the shade of the Yellow Water Lilies, and the surrounding poplars and scrub is casting enough shade and leaf litter to suppress it. Similar other species recorded in 2008 are present but in very low abundance, probably due to shade and leaf litter. Water quality appears to be a bit brown (possibly due to a build up of leaf litter) but fine. A dead tree stump has been deposited in the water. *Kniphofia*, or red hot poker garden plants, have been introduced on one edge. A couple of Great Crested Newt efts were netted and a few eggs noted but the invertebrate sample just contained a few freshwater shrimps and immature Corixid bugs.

## 2020 Recommendations

- Avoid putting fish in pond or encouraging duck.
- To improve a pond habitat, I would normally recommend the removal of shade and trees that are casting shade and leaf litter. However, the poplars may be the very reason that the *Crassula* has declined so I am wary of recommending their removal. Recommendations for dealing with *Crassula* have changed since 2008 and there is no easy or effective solution despite lots of ongoing trials with dyes, plastic coverings etc:

- Mechanical removal is no longer recommended as it simply breaks it up and potentially spreads it further.
  - There are no effective herbicides approved for use in water. However, if the pond dries out completely in a droughty year, applying glyphosate (approved for use in or near water) by someone qualified to spray in or near water could significantly check its growth. However, glyphosate kills all other plants that are sprayed too and the only way of killing the *Crassula* is to treat the whole dry pond floor – and even then it often returns the next year!

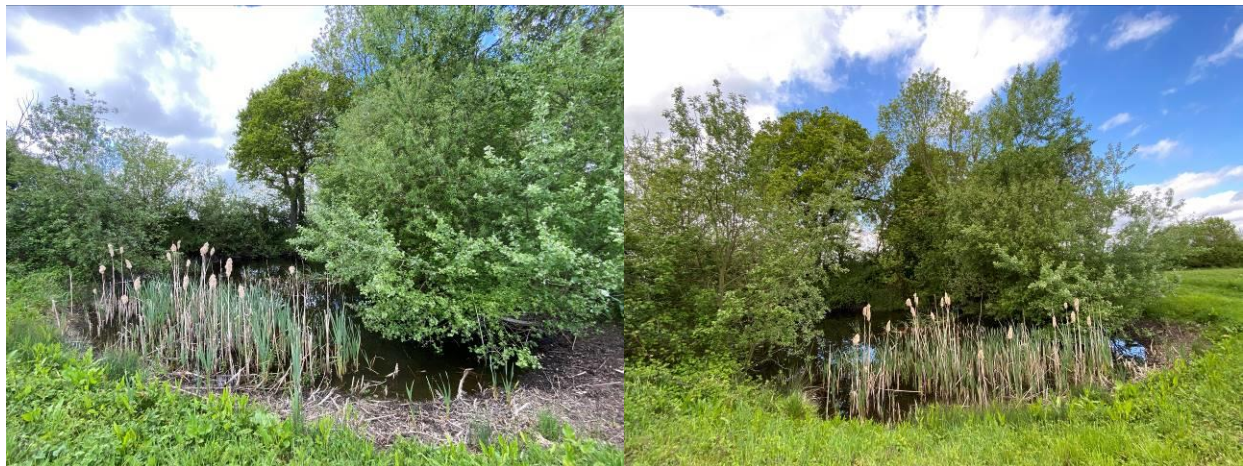
**7<sup>th</sup> May 2026:** Compared with the same time in 2023, this pond looked really quite lifeless. Even taking into account the cold, late spring, there was relatively little in the way of plant life and the water was brownish (?leaf tannins). The pond feels and is somewhat shaded – looking at the previous years’ photos one can see that it has become much more enclosed.

Some removal of scrub had been carried out on the eastern margin but more is needed to open up the margins to the north, south and east wherever accessible. Broadleaved pondweed and water crowfoot were not evident in the water, and false bulrush and branched bur-reed were taking over the one sunny, shallow south margin. No GCN eggs were recorded.

**2026 Recommendations**

- Continue to keep pond open and sunny on the Great Common southern side, with regular flailing or strimming of the steep bank.
- Cut back the grey willow on all accessible edges to really get some sun on the pond surface and the banks. Treat cut stumps with glyphosate.
- Remove invasive false bulrush and branched bur-reed – they will grow back – but maintain as shallow margins as possible. While GCN may still be breeding in low numbers here, this is best done in winter months but ideally in early November in an attempt to encourage rare spring-fruited stoneworts. Avoid any deepening or steepening the gentle banks.

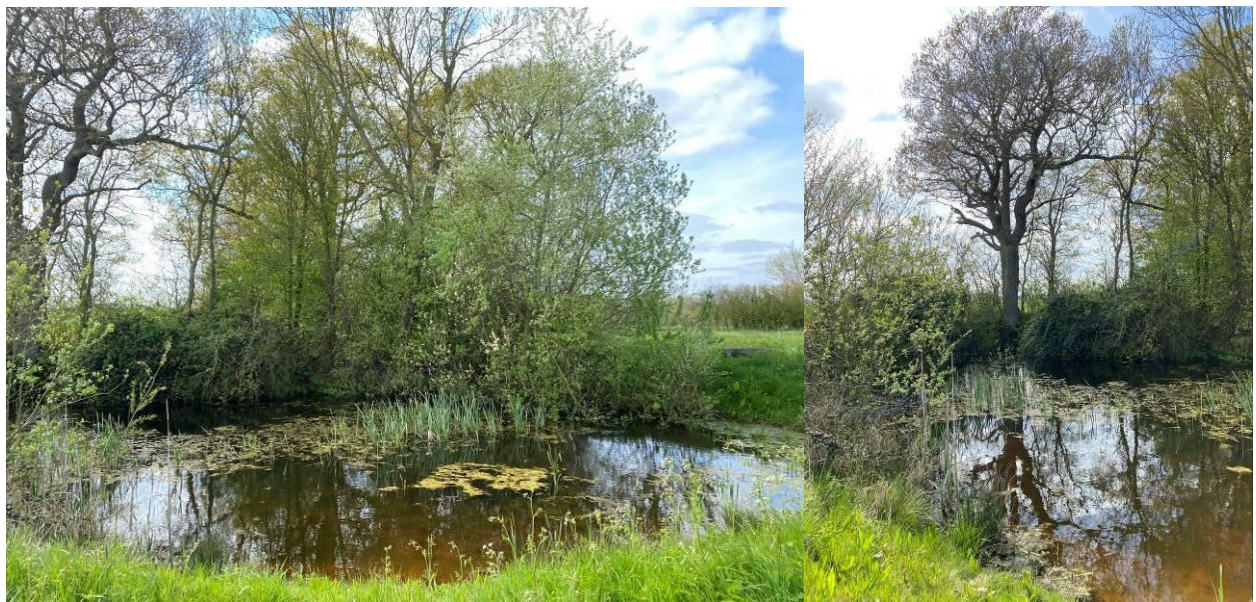
**3<sup>rd</sup> May 2023:** This low-set pretty common corner pond was restored in 2011 and patch-scraped over 40-50% or so of the pond in early November 2022. Great crested newt were recorded in 2020 and again evident in 2023 (eggs laid on last year's reedmace leaves) along with smooth newt. Water levels are as high as I have seen them with a good mix of at least 13 pond plant species seen from the accessible bank edge including about 10% of the water area covered in reedmace with additional broadleaved pondweed and water crowfoot (only horned pondweed missing from the previous year's list but it may be too early in the year to record this). Some blanketweed may be evidence of some enrichment/pollution from leaching/run-off into the farm ditch from adjacent arable that inflows into the pond but this should disappear as the plants start mopping up the excess nutrients.

There are a few willow seedlings evident along the steep grassy bank side which will need some control in the absence of grazing livestock at the margins. Invertebrate sampling yielded freshwater shrimp, hoglouse, leeches, saucer bug, cherry stone beetle, screech beetle, grooved diving beetle and various water boatmen.

#### 2023 Recommendations

- Continue to keep pond open and sunny on the Great Common side, and accessible to visit and monitor by occasionally cutting back rank vegetation, seedling grey willow and bramble on the steep/common-side accessible banks.
- Consider cutting back the large grey willow on the accessible western edge and selectively treating the stump of the grey willow once you have cut them by painting the cut stumps with glyphosate.
- Monitor regrowth of invasive species and consider a gentle patch-scape of 20% or so of the pond in the next five years or so. As GCN are breeding here, this is best done in winter months but ideally in early November in an attempt to encourage rare spring-fruited stoneworts. Avoid any deepening or steepening the gentle banks.

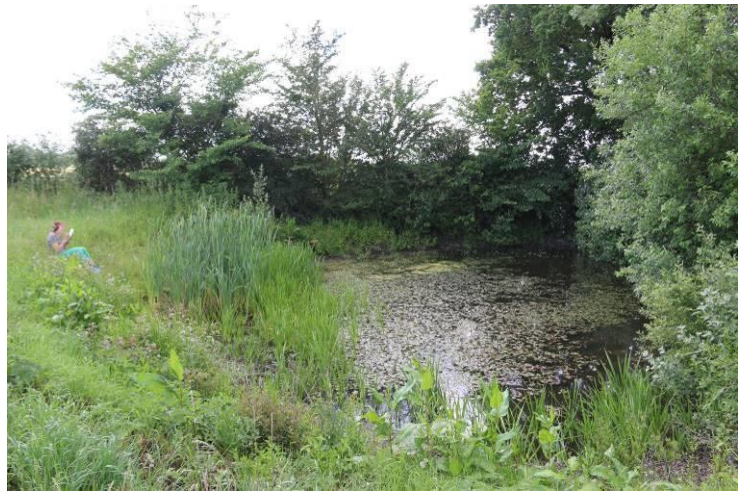
**15<sup>th</sup> June 2020:** A very healthy pond. Water levels were down 50cm or so during this droughty period but water quality was good with 20 species of aquatic or emergent plant recorded which is excellent. Azolla water fern was completely absent, having been frequent in July 2017 which is excellent news. Dragonflies, hoverflies, water beetles, pond snails and pea mussels were all observed. Smooth and Great Crested Newt were both recorded and no fish. The pond margins to the east have been cut back well so that the 10 small stools of grey willow are being kept at bay which is excellent.

### 2020 Recommendations

- Continue to keep pond open and sunny on Great Common side, and accessible to visit and monitor by occasionally cutting back rank vegetation, seedling grey willow and bramble on the accessible banks. Consider selectively treating the stumps of grey willow once you have cut them by painting the cut stumps with glyphosate.
- Cut back (and treat stump) of the grey willow and young white poplar from the northern edge.
- Occasionally gently winter patch-scape to reduce the spread of Reedmace, Branched Bur-Reed, willow seedlings, and to create some bare terrestrial banks for dragonflies. Avoid any deepening or steepening the gentle banks.
- Take care with hygiene for any machine used and wash it down afterwards to avoid contaminating other water bodies with *Azolla*.

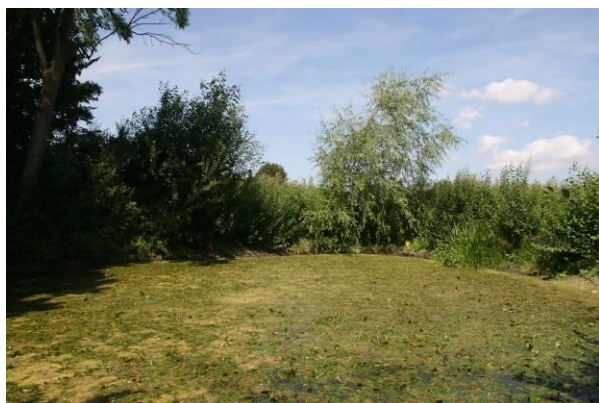
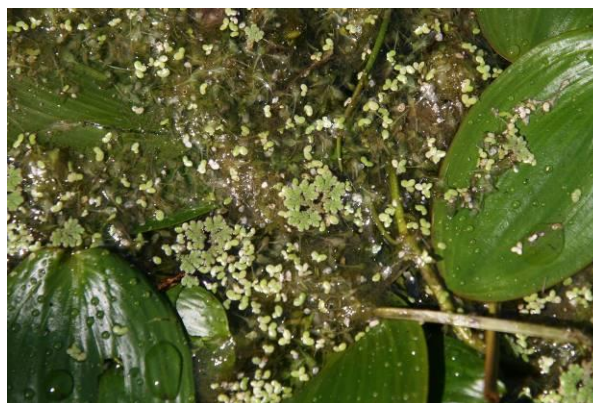
**Pond 3: 17<sup>th</sup> July 2017:** Water levels were quite low, leaving a beach of emergent species and a concentrated thick ‘soup’ of blanketweed algae, duckweed and *Azolla* water fern and very little open water (see photo over page). Water quality was very clear beneath and there was a lot of invertebrate activity with dragonflies and hoverflies. Smooth and Great Crested Newt were found in every pond dip. Thus whilst the pond is very densely vegetated, it appears to be healthy. Table below demonstrates how the pond has remained healthy with similar species but surveying the actual water body when the vegetation is so dense is difficult to do so I suspect other species were present too, simply not found.

### Recommendations

- *Azolla* is a non-native (and often quite invasive) species that occasionally appears on very sheltered ponds but it can quite easily disappear too another year so don’t worry about this whilst the competitive broadleaved pondweed is there to shade it out.
- Continue to keep accessible to visit and monitor by occasionally cutting back rank vegetation and bramble on the accessible banks.
- Remove tree seedlings as they appear.
- Occasionally remove a scoop of leaf litter organic matter from the most shaded side when the farmer adjacent has a digger in. Take care with hygiene for any machine used and wash it down afterwards to avoid contaminating other water bodies with *Azolla*.

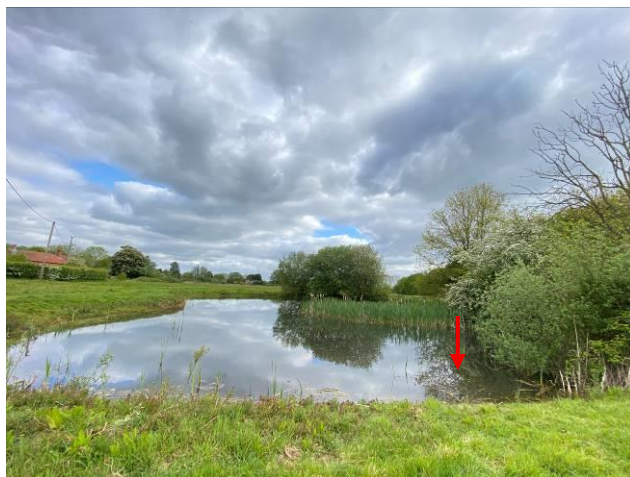
Pond from south west.

**Slimy-fruited stonewort was found in every area that had been scraped! Clustered stonewort** was found primarily in areas that had not been scraped (also some in patch-scraped areas) and where moss gets going but maybe light disturbance from dogs of the pond floor is enough to provide niches for it. **Red arrows on the photos below indicate where Slimy-fruited stonewort was found.**

This is really excellent and more evidence that October management of this shallow pond appears to benefit these two rare spring-fruited stoneworts. Great crested and smooth newt larvae were record in good numbers so they appear to be thriving under this regime too.

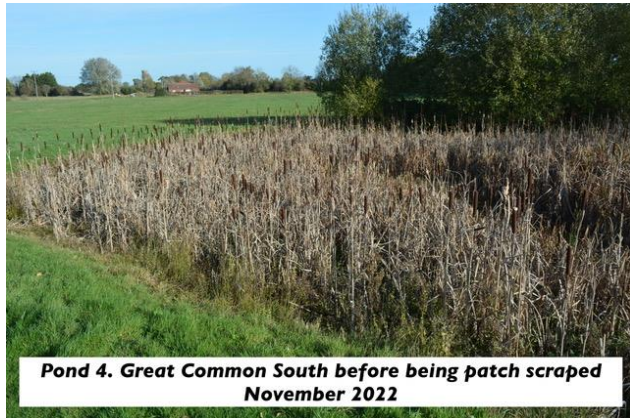
**Pond 4. Great Common South before being patch scraped  
November 2022**

**3<sup>rd</sup> May 2023:** This large shallow pond has been patch-scraped over 40% of the pond on 2<sup>nd</sup> November 2022 to remove swathes of invasive reedmace. Christopher Roberts' photos of one section below show how thick it had become and the bottom photo shows how it looks today. Prior to this it was last restored in 2008.

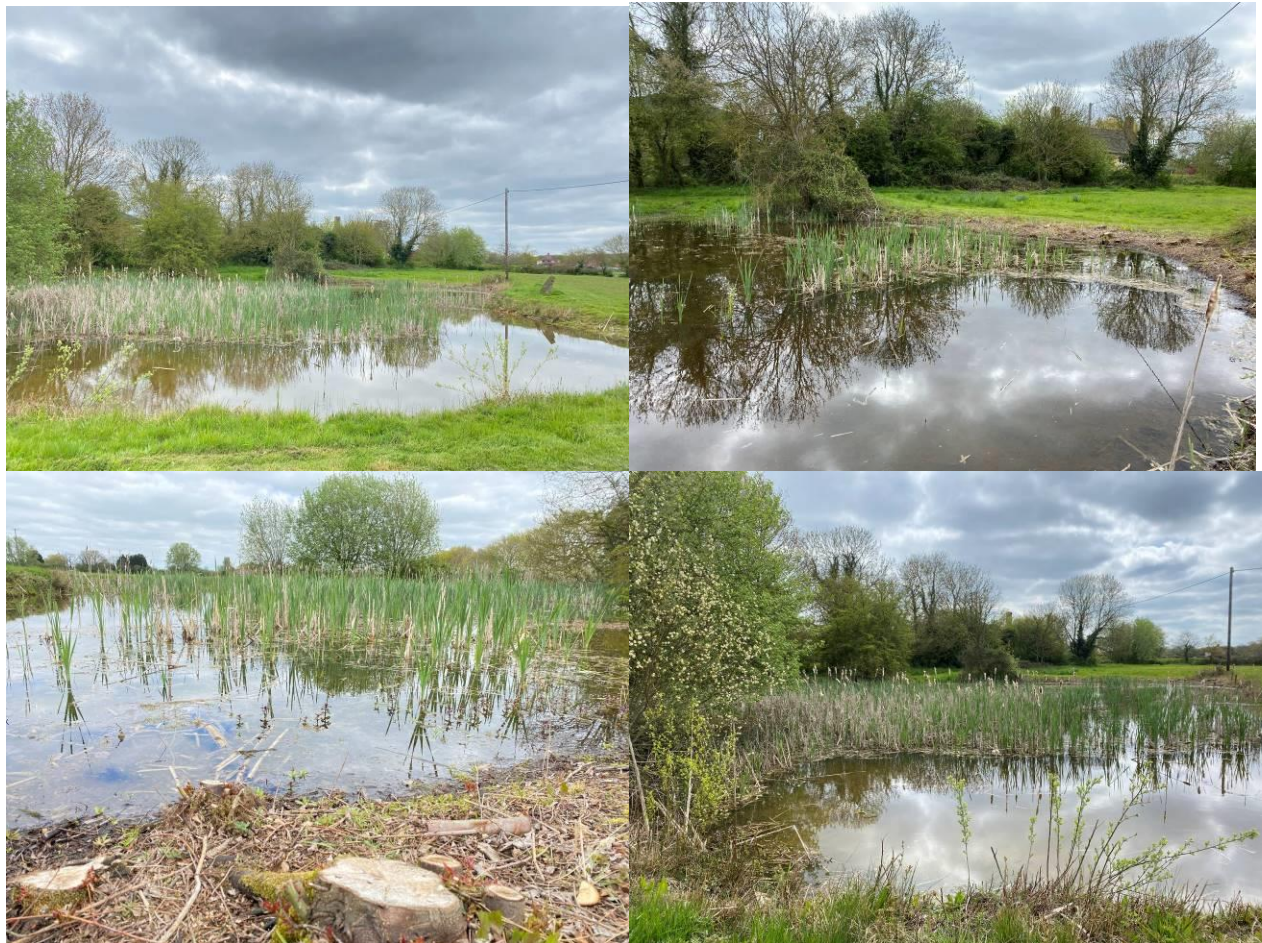
Despite a very late spring the pond was looking excellent and Great crested newt eggs were recorded in healthy numbers. 32 or so aquatic and emergent plants have now been recorded at this pond which makes it one of the most species-rich ponds for plants in Suffolk. Of particular note was:

- Previously recorded **Tubular Water Dropwort** recorded under the willow as indicated by the red arrow above.
- **Most significantly of all**, the spring-fruiting **Slimy-fruited stonewort** *Nitella capillaris* was recorded sporadically across a wide swathe of pond growing entangled with the Nationally Scarce **Clustered stonewort** *Tolypella glomerata* (pictured right).

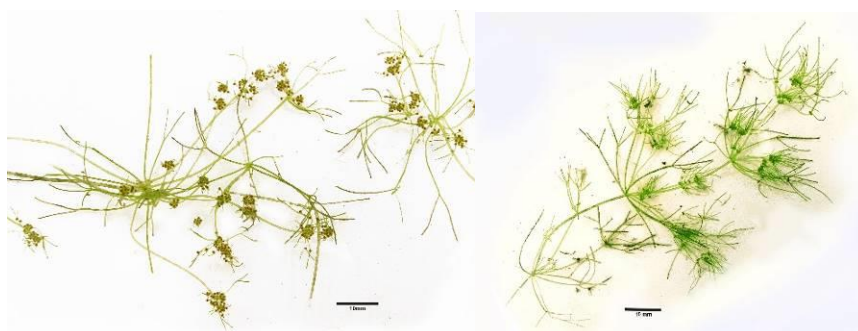
*Left to right: N capillaris male plant, female plant and fruiting body. © Chris Carter*

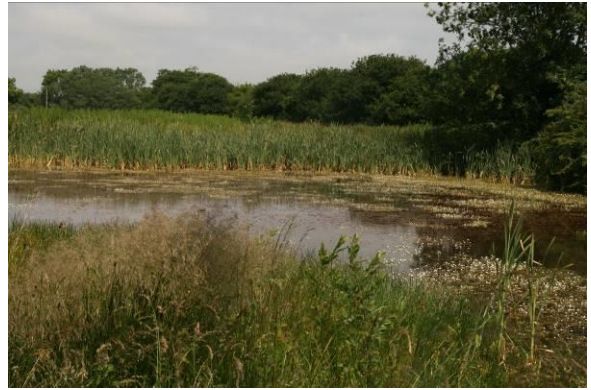
**8<sup>th</sup> July 2013:** The pond has clearly had some work done to it including the removal of some reedmace. This pond was looking superb with an amazing diversity of vegetation with 23+ species of aquatic/emergent plant (12+ in 2008) which is a really excellent number for a Suffolk pond. This included **Tubular Water Dropwort (*Oenanthe fistulosa*) – classed as Vulnerable and now a priority BAP species**, found in one small patch. Reedmace (*Typha latifolia*) was not as dominant as in 2008 but still provides a good stand of vegetation. There was a large bed of water crowfoot (*Ranunculus peltatus*) – I could only see pond water crowfoot up close but the large stand of it could have been a second species, common water crowfoot (*R. aquatilis*). *Crassula* was not evident from the accessible edges (I wonder what control method you used?) and there was no blanketweed algae.

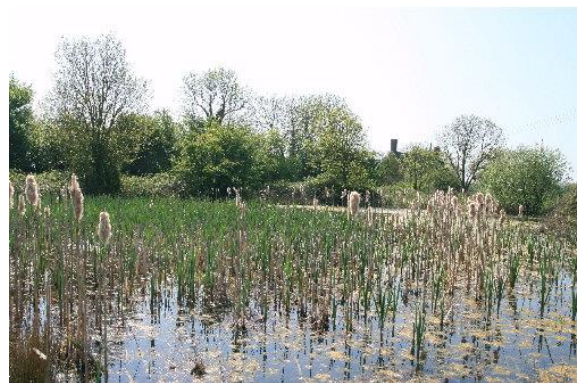
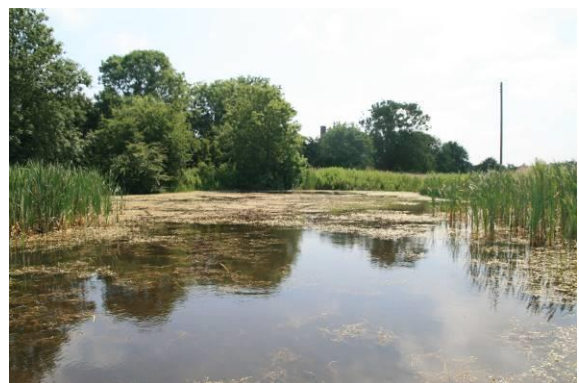
This large shallow, open pond is dominated by invasive Typha and *Crassula* has started to come in too. Good quality water with some blanketweed algae. Good habitat for dragonflies, pond skaters, water boatmen.

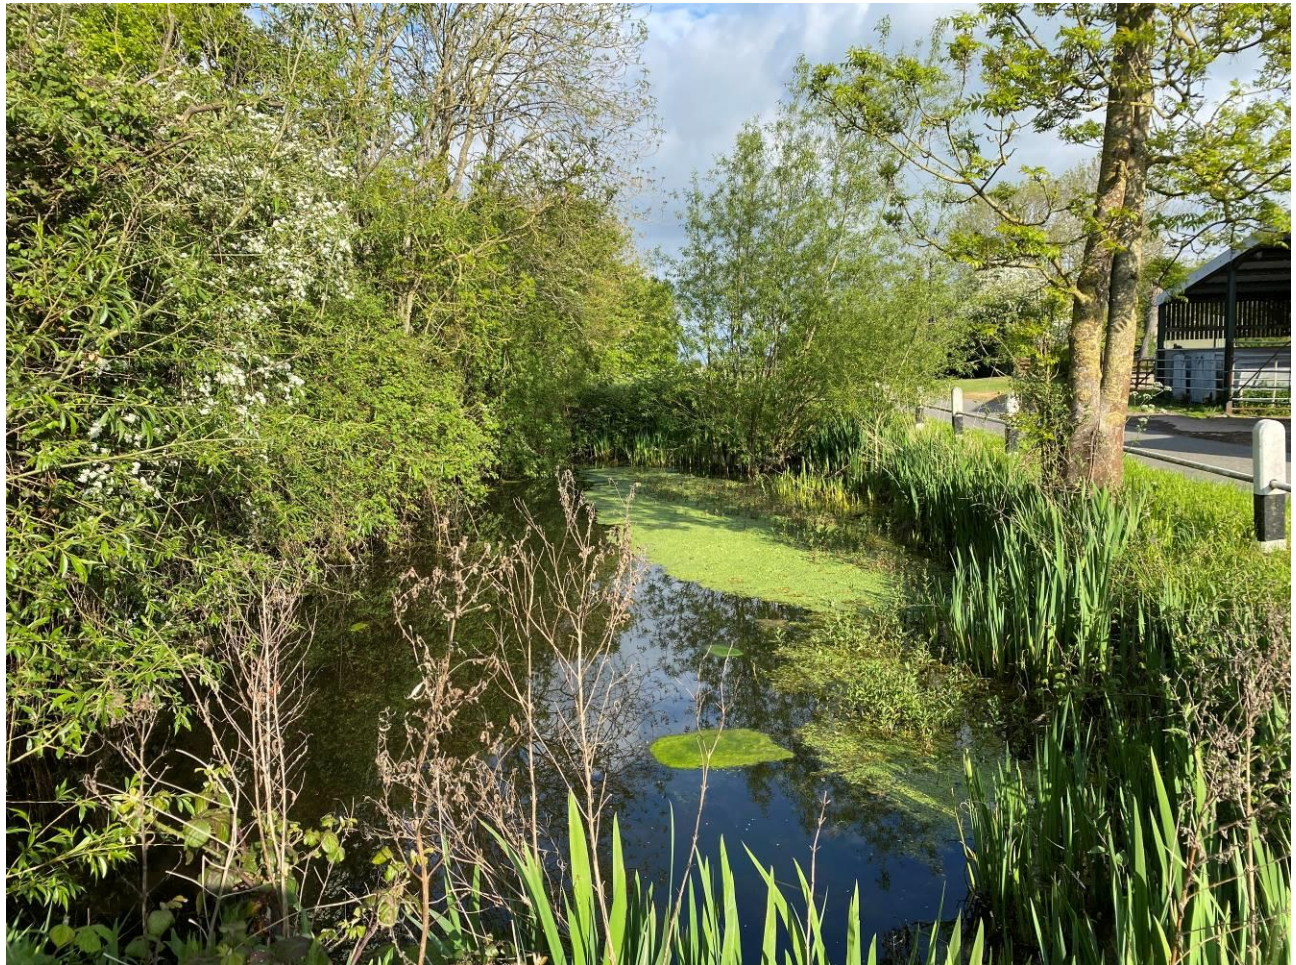
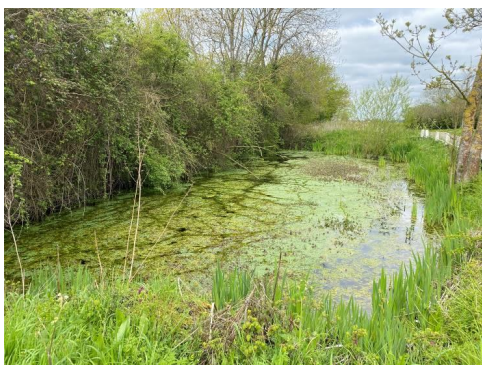
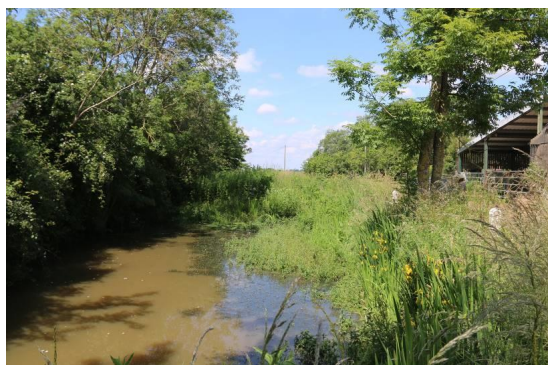
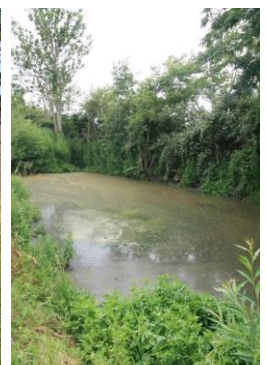
**7<sup>th</sup> May 2026:** This pond has been transformed compared to 3<sup>rd</sup> May 2023 and previous years (see bottom row of pics on this page). Less than 10% of the pond was covered in blanketweed algae, the water looked very clear with the bottom of the shallow 1m deep pond visible and a good number of GCN eggs were visible on frequent water mint. It would appear that a source of effluent or enrichment has been diverted which is excellent. A moorhen is breeding. The willows at the western end have grown somewhat and are casting more shade, and the hedge is overhanging and shading more.

- Continue to try keep any polluted water from entering the pond.
- Continue to keep the pond open and sunny. Cut back all accessible willow and overhanging hawthorn where you have a right to do so to maximise sunlight.
- Patch scrape a small section of the pond, say 15% of the accessible bank, when next patch-scraping elsewhere and review the results.

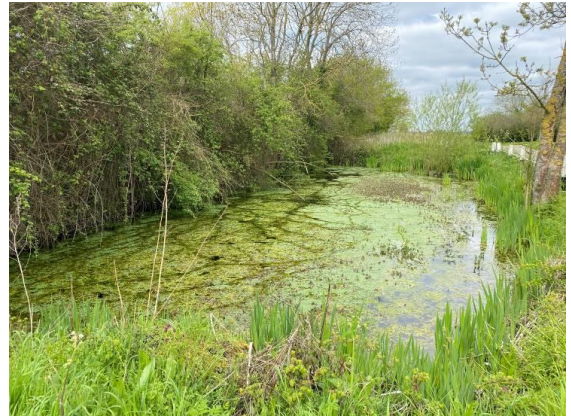
**3<sup>rd</sup> May 2023:** This pond was full of water and densely vegetated through the water column with floating and submerged algae, water starwort and water speedwell with occasional willow seedling on the margins but scrub had been cut back to keep the pond open. There was little open water or bare substrate. Moorhen paths can be seen across the water.

The pond probably still receives a fair amount of nutrient-rich runoff from the cattle sheds on the other side of the road and this inevitably results in enriched water full of algae. At present the starwort is helping to 'mop' up these nutrients and it is in much better condition than in 2013 when it supported few plants except at the margins. There was too much algae to sample for invertebrates.

- Continue to try to divert polluted water from entering the pond.
- Continue to keep the pond open and sunny. Remove grey willow and thorn seedlings that get established.
- Patch scrape a small section of the pond, say 15% of the accessible bank, when next patch-scraping elsewhere and review the results.

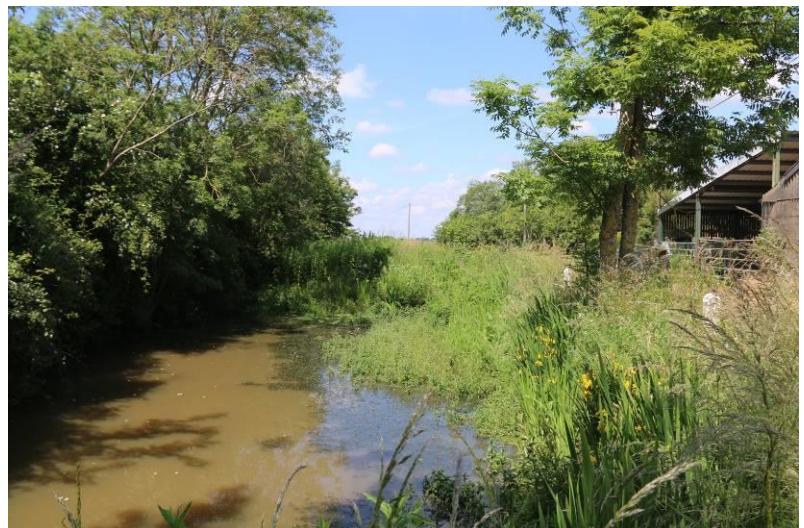
**15 June 2020:** This pond remains much the same every year with a fairly good variety of plants in this fluctuating waterbody and, rather surprisingly, two Nationally notable water beetles and caddis larvae were recorded this year, sampled from the quite anaerobic shallow muddy and quite murky water. I still suspect seasonal runoff from the farm buildings opposite which brings nutrients/pollutants but the marginal vegetation is doing well. Grey willow is seeding in at the margins and needs controlling.

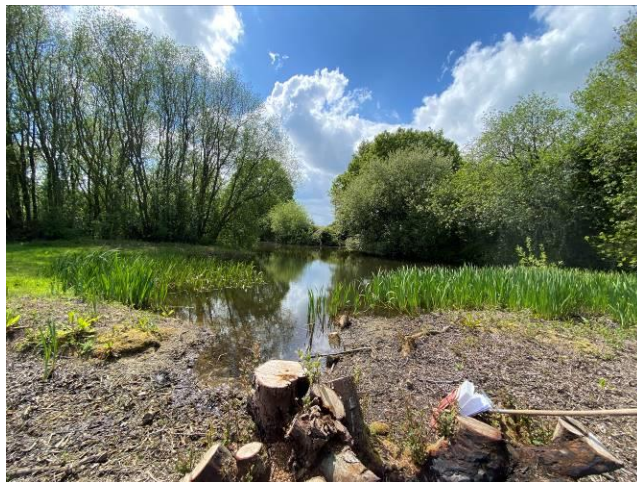
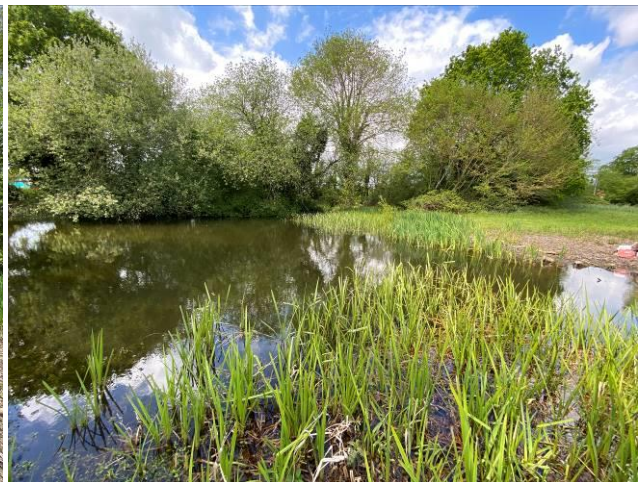
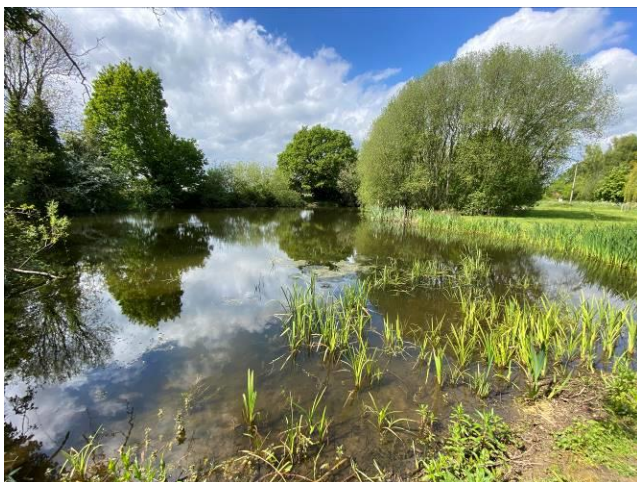
The Mardle was beautifully restored in October 2025 with very gently grading edges and spoil sensitively dealt with. 17+ pond plant species were recorded in the very clear water. The western edge and some other banks have plenty of scrub and overhanging branches – these will be sources of plenty of seedlings to manage in the future!

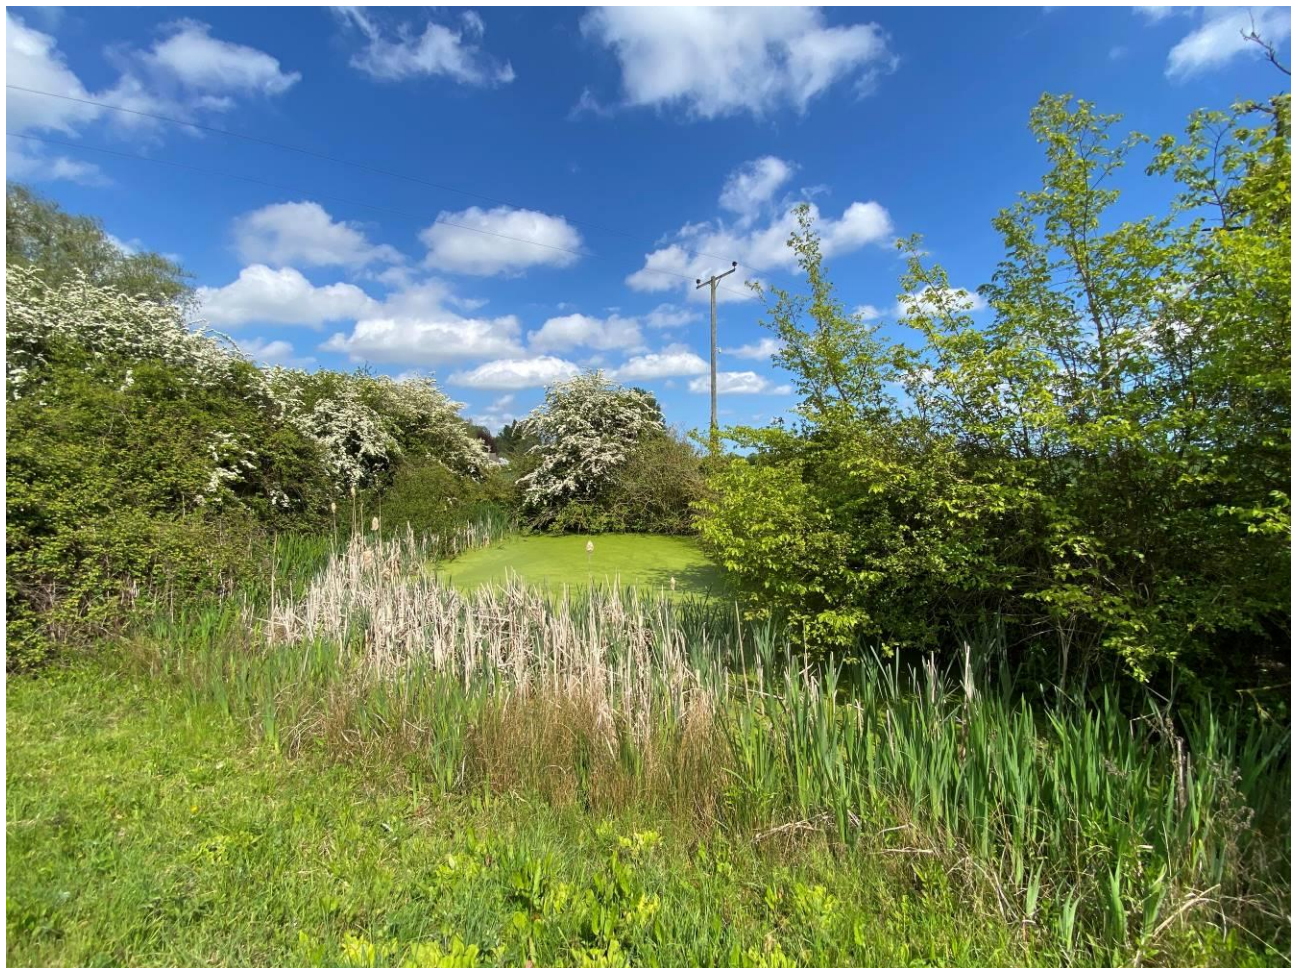
**7<sup>th</sup> May 2026:** The pond is completely covered with duckweed and densely vegetated with reedmace and flag iris right up to the accessible pond edge and so impossible to sample for invertebrates. The duckweed indicates, as in 2023, that a considerable depth of organic matter either brought in and deposited where the ditch meets the pond, or from years of leaf litter build up from overhanging shrubs at the margins. Either way, the full wildlife potential of the pond is limited by so much organic matter. No GCN eggs were recorded but could be there – it was just impossible to see through all the duckweed. A wren and whitethroat were singing from the thick shrubs to the north of the pond. As a stand of emergent vegetation with scrub, this presents a good alternative habitat on the edge of this common.

- As before, consider water testing by the Environment Agency to identify the source of any pollution if you suspect it and feel something can be done about preventing it. Otherwise leave the reedmace and marginal plants to absorb as much of the enriched water as it can to reduce pollutants carrying on downstream.
- Until any nutrient inflow burden can be reduced, I think this pond is a low priority to restore. Restoration would involve removal of a large amount of organic matter, spreading nearby ideally on arable land and cutting back some overhanging scrub on the margins.
- Continue to keep the pond open and sunny on the Little Common side by regular strimming as you are doing now.

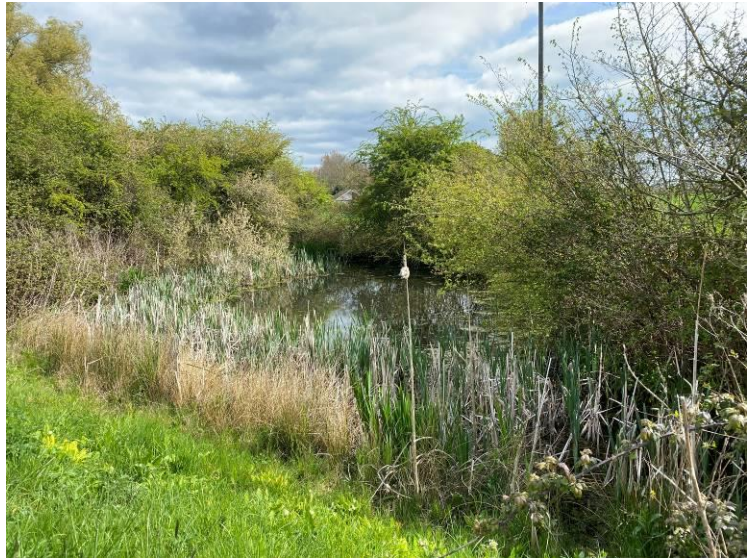
**3<sup>rd</sup> May 2023:** This full pond has a firmish shallow margin on the western edge but has 25cm depth of organic matter one metre into the pond so I assume it receives an inflow with a big organic matter burden. Whilst it has a fringe of emergent vegetation, it is devoid of all aquatic plants indicating a considerable depth of organic matter either brought in and deposited where the ditch meets the pond, or from years of leaf litter build up from overhanging shrubs at the margins. Either way, the full wildlife potential of the pond is limited by so much organic matter. Great crested newt eggs were recorded on watercress at the margins but this is very much a sub-optimum pond habitat for them.

- As before, consider water testing by the Environment Agency if you suspect pollution and feel something can be done about preventing it. Otherwise leave the reedmace and marginal plants to absorb as much of the enriched water as it can to reduce pollutants carrying on downstream.
- Until any nutrient inflow burden can be reduced, I think this pond is a low priority to restore. Restoration would involve removal of a large amount of organic matter, spreading nearby ideally on arable land and cutting back some overhanging scrub on the margins.
- Continue to keep the pond open and sunny on the Little Common side by regular strimming as you are doing now.

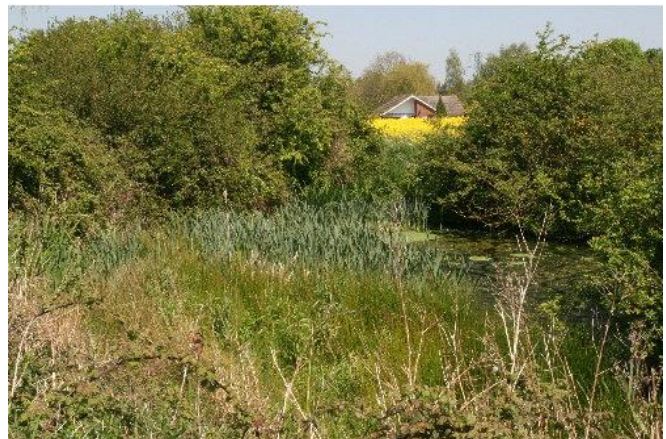
**15<sup>th</sup> June 2020:** This pond is still devoid of aquatic plants but a similar community of emergent plants were recorded on the western pond fringe bordering the common where the scrub is kept back by regular strimming and a silt burden is trapped by the Reedmace. No amphibians, dragonflies or damselflies were recorded. Blanketweed was recorded in the water suggesting it is still receiving nutrients from upstream.

- As 2017, consider water testing by the Environment Agency if you suspect pollution and feel something can be done about preventing it. Otherwise leave the reedmacro to absorb as much of the enriched water as it can to reduce pollutants carrying on downstream.
- Until any nutrient inflow burden can be reduced, I think this pond is a low priority to restore.
- Continue to keep the pond open and sunny on the Little Common side by regular strimming as you are doing now.

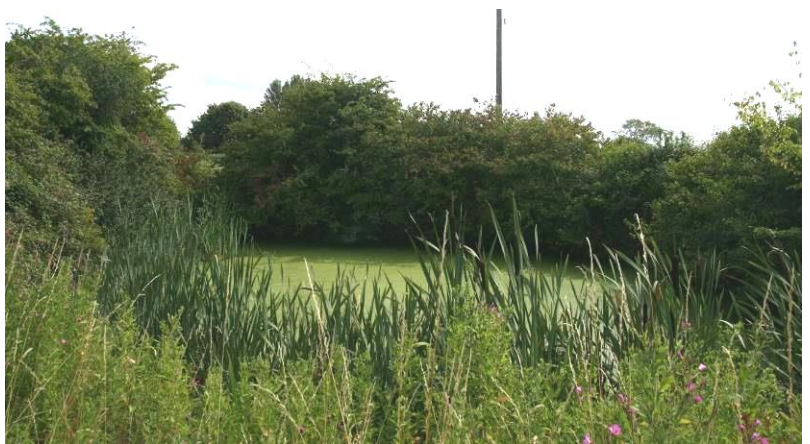
**Pond 8 – 17<sup>th</sup> July 2017** **Pond 8:** The pond margins have changed little except to be predominantly reedmacro. It was restored in 2011 but in the accessible 1m or so in from the pond edge, it is full of duckweed covering smelling anaerobic organic matter implying a heavy (possibly seasonal) inflow of organic matter that gets brought in by the ditch, and possibly some pollutants such as sewage from houses upstream. Dipping yielded very few invertebrates (no sample taken). It is a water source for wildlife in dry years.

- Consider water testing by the Environment Agency if you suspect pollution and feel something can be done about preventing it. Otherwise leave the reedmacro to absorb as much of the enriched water as it can to reduce pollutants carrying on downstream.
- This is a low priority pond to restore again so soon by removing organic matter but if you do, I suggest you leave/place some reedmacro near the inflow to act as a natural filter on nutrients coming down the ditch.

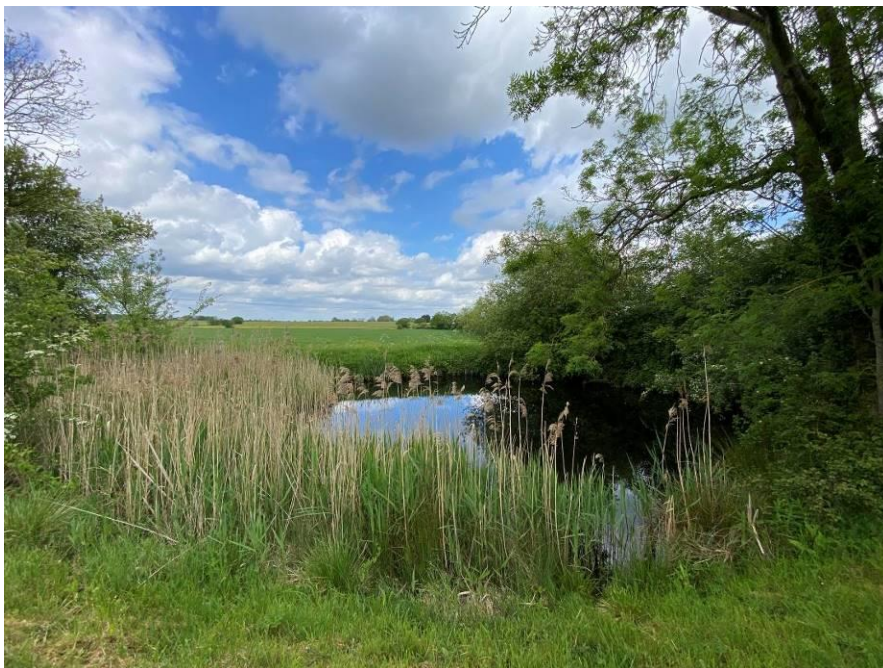
**7<sup>th</sup> May 2026:** Common reed now accounts for about 60% of the pond – the shallow shelf to the west of the pond, and the fringe along the southern edge with reedmace – and willow has started to seed into the shallow shelf where the reed is drying it out. For reed bunting, other warblers and moorhen this represents a good habitat for nesting and foraging. Moorhen, chiff-chaff and whitethroat were all recorded in the reedbed/margin. However, it does mean that the shallow water areas are not supporting any other emergent vegetation and diversity which limits the opportunities for other species. Dogwood, thorn, rose and willow are all getting well established on the southern margins adjacent to the reedbed. And as an onlooker, one can't see into the pond very far and there is little accessible bank to survey for invertebrates from. Shrubs to the north and east are also overhanging quite heavily.

With limited visibility/access, and a late spring, the long list of pond plants noted in 2020 was not evident and where plants were present, there were few.

- Management advice for Norfolk Hawker is to never clean all pond banks of vegetation in any one year which re-enforces the above patch-scraping advice to occasionally remove vegetation from small areas rather than do a wholesale restoration of a pond. It also likes trees and shrubs close to breeding sites to hunt and roost in.
