## POND SURVEY 2026

### ILKETSHALL ST ANDREW COMMONS

**POND SURVEY & MANAGEMENT RECOMMENDATIONS MAY 2026:  
ILKETSHALL ST ANDREW COMMONS**

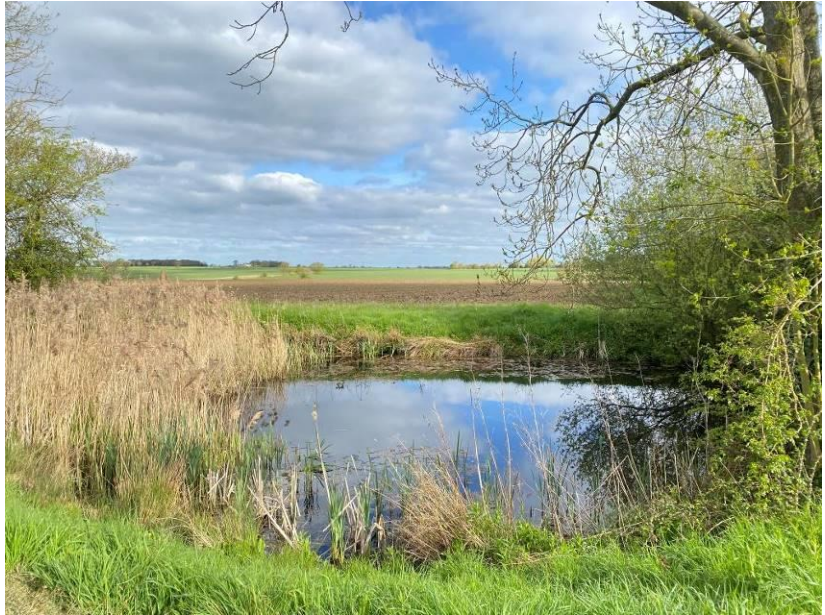
**3<sup>rd</sup> May 2023:** This lovely pond is now a pond of two halves: a dense reedbed on the shallow shelf with a seasonally fluctuating water level which will provide nesting for reed bunting; and an open water area with clear, clean water which is well vegetated with broadleaved pondweed and a good range of 18+ plants, some shade to the eastern end. GCN eggs were evident. An invertebrate sample yielded dragonfly, damselfly and mayfly nymphs, leech, freshwater shrimp, hoglouse, ramshorn snail sp, water beetles and water boatmen. Reedmace is beginning to spread along the southern edge of the pond which will effectively block one's view into the pond but not damage wildlife habitat. Thorn, rose and willow are regenerating along the southern, common-side bank.

- Continue to trim and keep willow, rose and bramble scrub from spreading into the currently sunny open margins to the north and south.
- If water levels drop, hand pull the reedmace out where accessible to slow its spread from the one open place into the pond.

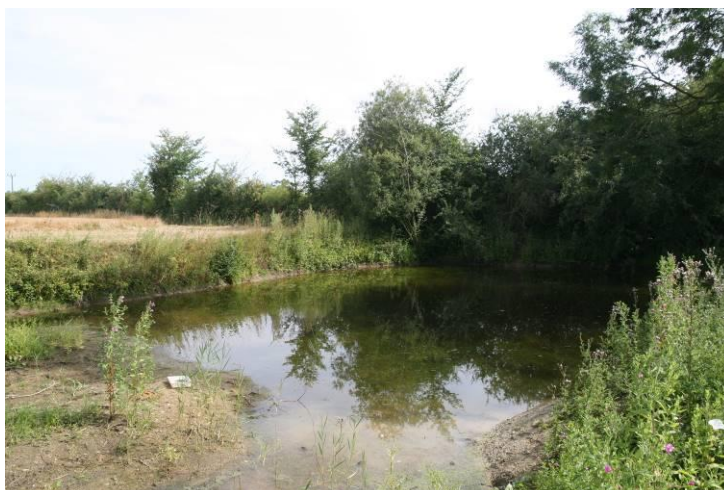
**Pond 10 17<sup>th</sup> July 2017:** The pond was cleaned out in autumn 2016, with spoil spread on the meadow to the south and left to naturally regenerate. **The pond has been transformed** and is now dense with stonewort and some water crowfoot and the muddy shallow areas, left drier as summer water levels have gone down, are being colonised by celery leaved crowfoot, gipsywort, water plantain, reedmace, hard rush and jointed rush. Smooth newt were numerous amongst the stonewort and I am sure Great Crested Newt will colonise soon if not already.

An emperor dragonfly was patrolling while another was ovipositing. Four-spotted chasers and common blue damselflies evident too. There were nine butterfly species observed in a very short time on the spoil and hedge adjacent including brown argus, small copper.

- When levelling off the spoil this autumn, consider spreading species-rich hay debris over the disturbed area to speed up the colonisation by local plants.
- Regularly re-coppice or even occasionally flail the pond edges to minimise/slow down the rate of regeneration of sallow and other shading shrubs - and possibly create a winding path that takes in the pond margin – and to enable visitors to see into the pond along some or all of its southern common margin.
- Allow patches of bramble and grass to grow up where it is not on species-rich grass as this provides really good roosting and hunting sites for dragonflies and good cover for snakes and amphibians. However, ensure that the pond does not get any shadier as this will simply shorten the time when you will need to restore it all over again!

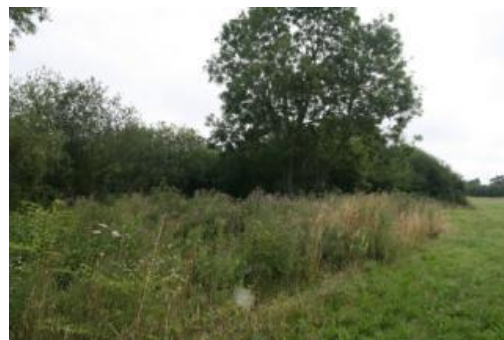
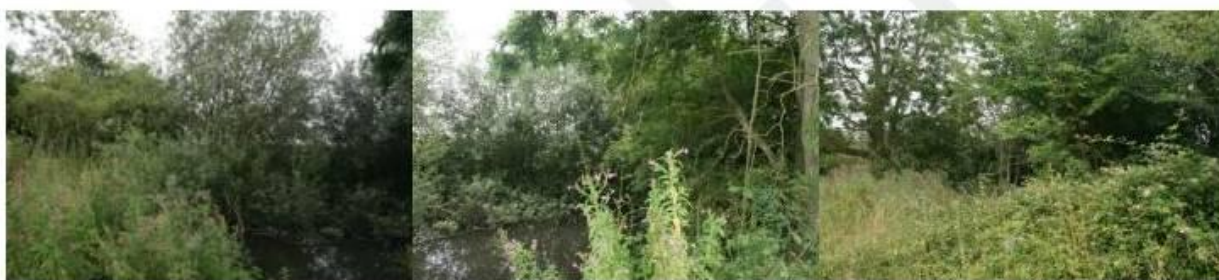
**Pond 10 30<sup>th</sup> July 2015:** A large amount of scrub has been cut along the common side of this linear pond on the northern edge of the common and opened up part of the pond this last 2014/15 winter. The immediate common margin is now growing spear thistle, rank grass and nettles on the burn site. The response has been minimal except on the margins where hard rush, bittersweet, gipsywort and water figwort have germinated. The water is brown and full of leaf litter and organic matter – no aquatic plants. It is still not newt-friendly although they may have colonised the local area in the hope of some aquatic plants to lay eggs on!

The northern fairly steep field edge (neighbouring farmer's arable field, see 2008 picture above) has grown up with sallow along the

margin now so the sun is not getting to a sunny-facing margin. The eastern edge of the pond is still scrub, bramble and a large ash tree with fairly clean sides to its trunk.

- This is a potentially lovely pond edging onto the common and further restoration work would be worthwhile.
- Continue to coppice along the common side but leave the ash tree as a feature as it allows plenty of light under its high branches. Consider treating stumps to minimise regrowth and effort in re-coppicing. Pile some cut logs to create a snake/amphibian winter refuge.

- Remove spoil off site and consider scraping off a layer of top soil from the area of former burn site and thistles. Consider spreading species-rich hay debris over the disturbed area adjacent to the pond when you have finished work to speed up the colonisation by local plants.

- Thereafter regularly re-coppice or even occasionally flail the pond edges to minimise/slow down the rate of regeneration of willow and other shading shrubs – and to enable visitors to see into the pond along some or all of its southern common margin. Re-coppice willow on the northern edge regularly. Allow patches of bramble and grass to grow up where it is not on species-rich grass as this provides really good roosting and hunting sites for dragonflies and good cover for snakes and amphibians.

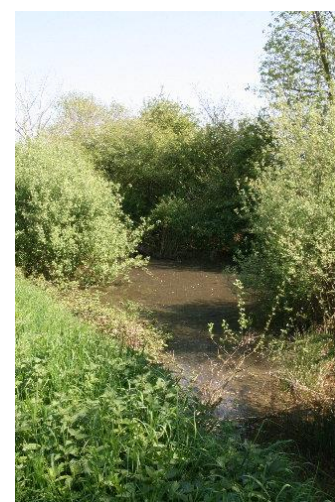
**8<sup>th</sup> July 2013: Completely shaded and no work done.**

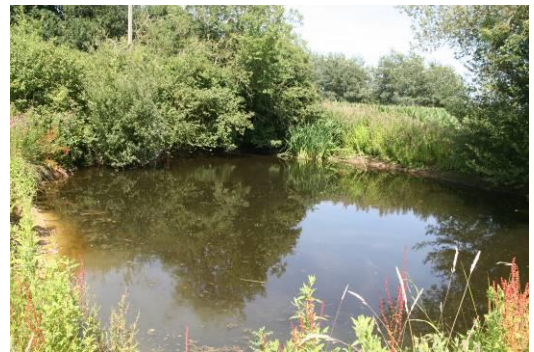
**Pond 11 17<sup>th</sup> July 2017:** The pond was indeed coppiced and cleaned out in autumn 2013/2014 and the pond proved to be very deep indeed (14ft+). Strangely the pond is full of brown quite murky water and still, three years on, appears to have no aquatic plants at all but does have emergent plants along the season littoral zone: fleabane, gipsywort, willowherb, hard rush, flag iris. Whilst deep, steep-sided and thus somewhat colder than other ponds, I am surprised that no aquatic plants have colonised. Dipping yielded sludge and organic matter (freshwater shrimp, hoglice and common blue damselflies - all tolerant of pollution), so I think that the inflowing ditch is bringing organic matter or a fair amount was left when restored, and possibly seasonal pollutants, that may be affecting water quality and consequently the ecology.

- I note that back in 2008 I mentioned a much heap at the arable field edge and wonder whether this is still sited there and if so whether this is a source of pollution? Apart from sorting this out, I am at a loss to know why the pond appears to lifeless and suggest that water quality is tested by the Environment Agency.
- Keep the margins open as now. Monitor plant growth, water levels, possible sources of pollution.

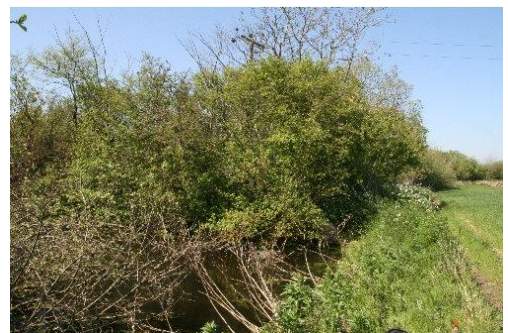
**13<sup>th</sup> July 2013:** The pond appears to have been opened up on the CWS Mill Common side but organic matter has not been removed as there is no aquatic vegetation at all.

The only plants growing are willowherb, bittersweet, soft rush and flag iris along the margins. Hoglice, freshwater shrimp, water boatmen, ramshorn snail and red worms were recorded which will provide some food for newts and other creatures which will continue to hang on in the pond in low numbers, breeding on fallen leaf litter and occasional submerged leaves of willowherb and bittersweet.

- Until the organic matter can be removed and spread off site, pond wildlife will be limited here as there is a thick layer of anaerobic matter on the pond floor.
- However, continue to keep the CWS common side open and free of trees and hopefully in time, the pond can be cleaned out. Regularly re-coppice accessible, owned trees/shrubs to minimise leaf fall.

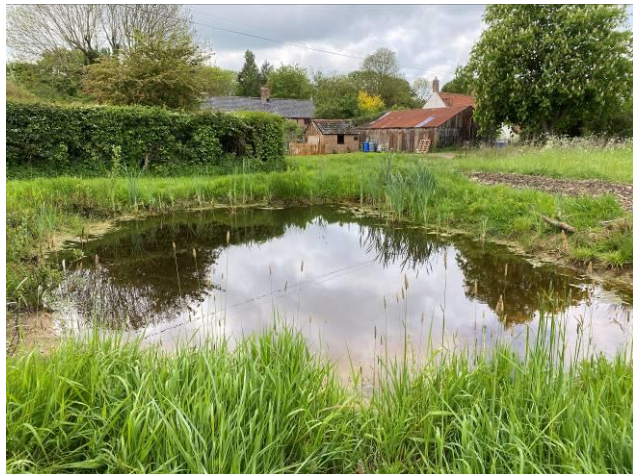
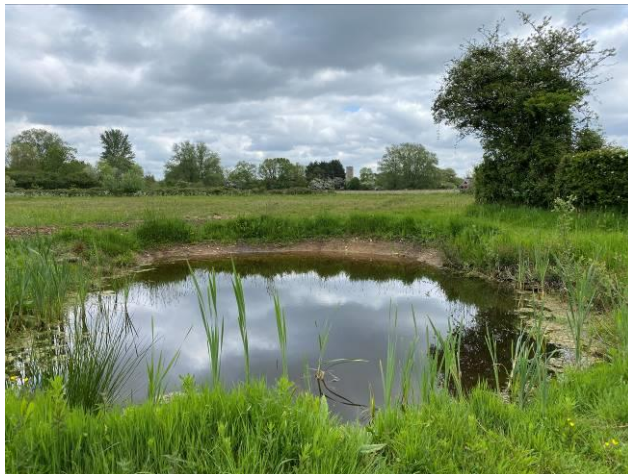
### **Pond 13 Great Common S rear of Coverly Cottage TM 37662 86916 - GCN recorded 2023 & 2026**

**7<sup>th</sup> May 2026:** This small pond has been nicely cleaned and extended a short way northwards to create a gentle shelf in October 2025. The precarious ash tree has gone and the water is clear. In addition to 2023 recorded plants, starwort and water crowfoot have colonised which is a good indicator of clean water with no algae compared to a 55% cover in 2023. Reedmace has started to spread and will do so in this shallow small pond quite quickly – but removing them every few years when other ponds are being managed should not be a problem. GCN and smooth newt eggs were recorded in low numbers. Grooved diving beetle observed swimming.

- Monitor growth and spread of reedmace and be prepared to remove it when you have a digger nearby.
- Cut and treat or remove willow seedlings that seed onto the bare, shallow, fluctuating banks.

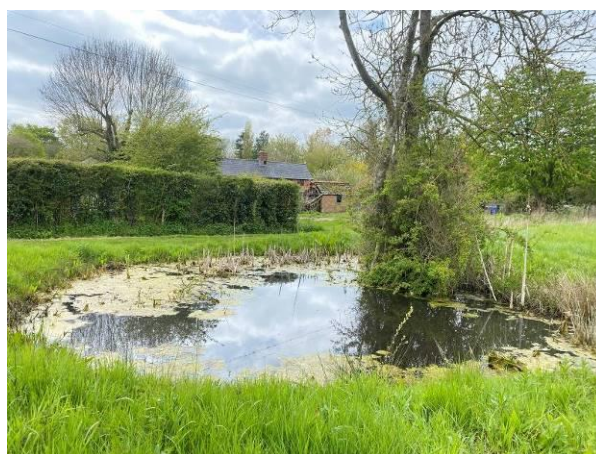
**3<sup>rd</sup> May 2023 :** This small 90m<sup>2</sup> and comparatively deep (1m+) pond has not been surveyed as part of the Commons ponds before. The small round pond has 6 plant species along the margins but the lack of any aquatic plants suggests that the 25cm organic matter burden over the firm substrate is limiting them. The floating and submerged algae also suggest some nutrient enrichment from ash tree leaf litter on the margin. There is some reedmace in the pond and GCN eggs were observed on greater willowherb at the margins but this is not an optimum pond habitat for GCN in its current state.

- Restore pond by removing organic matter (ideally by mid-October to early November) and ensure that the margins are left shallow and with a very gentle gradient as would be created by livestock using the pond.

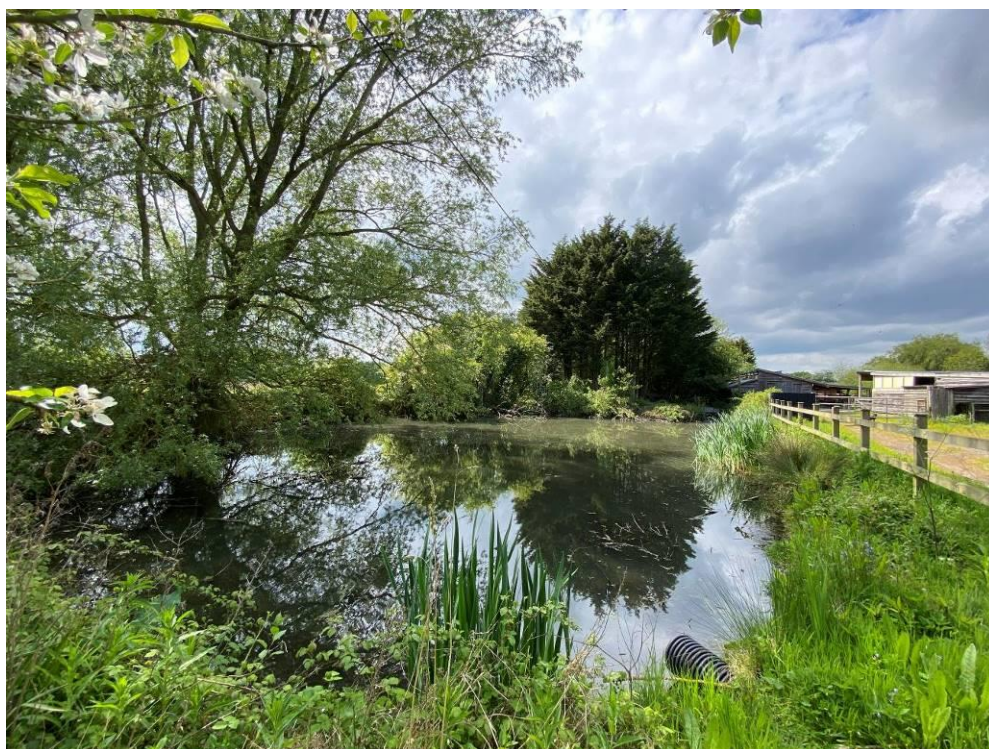
**Pond 15 Great Common Pond north adjacent to Glebe Farm TM37815 87097 – 500m2**

**7<sup>th</sup> May 2026 (not surveyed before):** This pond is marked on the old OS 1830s-1880s map as pretty much the same size and shape as now with a long wide ditch to the west and another inflow or overflow from the east. As it has been adjacent to farm buildings for a long time, this pond might have been what was referred to as 'Bumbay' effectively a slurry pit taking effluent run off from the farm buildings historically – and in the more recent past. The pond was restored in the early 1990s but it may have received effluent/pollution more recently and may explain why it appears lifeless with no aquatic plants evident at all and only flag iris, greater willowherb and reedmace on the shallow margins. The pond appears quite shallow (but may just be silted giving the illusion), full of organic matter and branches.

Its close proximity to Great Common Pond South with the Slimy-fruited stonewort and shallow nature makes it an interesting pond with potential for stonewort conservation IF one can be sure that once cleaned, the water will remain clean. Its lack of plants and wildlife including great crested newts mean this pond could be cleaned out at the optimum for spring-fruited stoneworts.

- Research any pollution points and ensure these can be prevented in the long term. If that can be sorted, consider restoration.
- This is a large pond and a large task. Restoration would involve:
  - Ideally restore when the water level is at its lowest in late summer/early autumn which might also benefit Slimy-fruited Stonewort if there are oospores buried in the mud.
  - Remove organic matter and spread spoil well away from any sensitive, species-rich grassland on the Commons.
  - Create a shallow access that there would have been – probably at the eastern end.
  - Retain large areas of bramble and large willow at eastern end, thorns at western end.
  - Monitor for stoneworts the following spring!
